Source: *WorkWise* (State Coroner's Office and Victorian Institute of Forensic Medicine publication)

Forklifts Kill

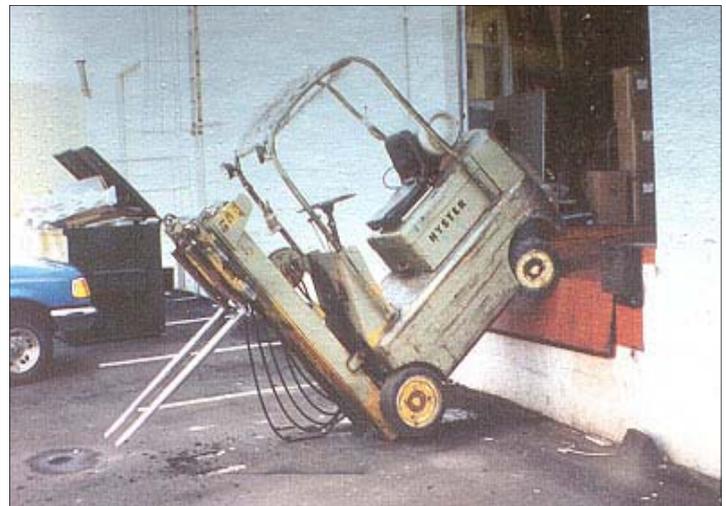
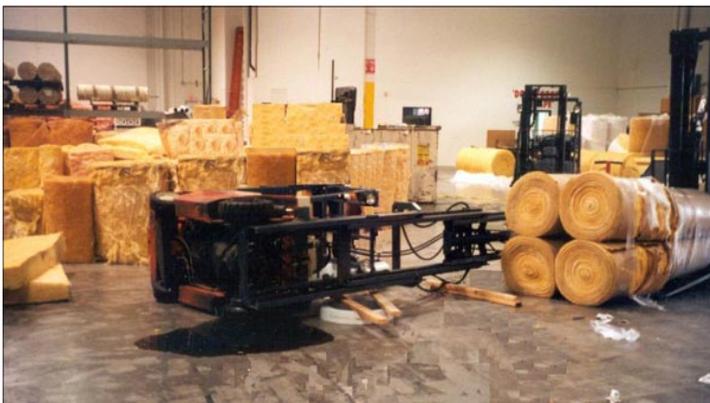
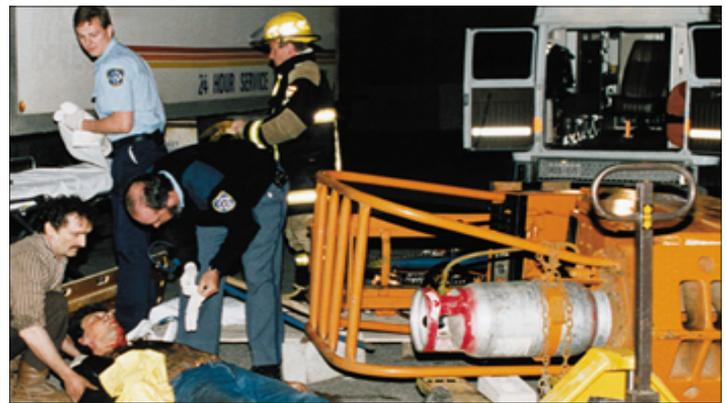
Forklift seatbelts save lives!

1. Seatbelts to be fitted to all forklifts to secure the driver;
2. "Wings" to be fitted to both sides of the forklift seat to prevent the driver falling out due to roll over;
3. Continuous safety training and bi-yearly assessments of persons using forklifts; and
4. Solid tyres to be used on forklifts instead of inflatable tyres.
